THE MORTON PARTNERSHIP LTD.

**RE: WELSH STREET, LIVERPOOL**

As you know I was able to visit in late February 2011 when I did a review of the structural condition of the buildings.

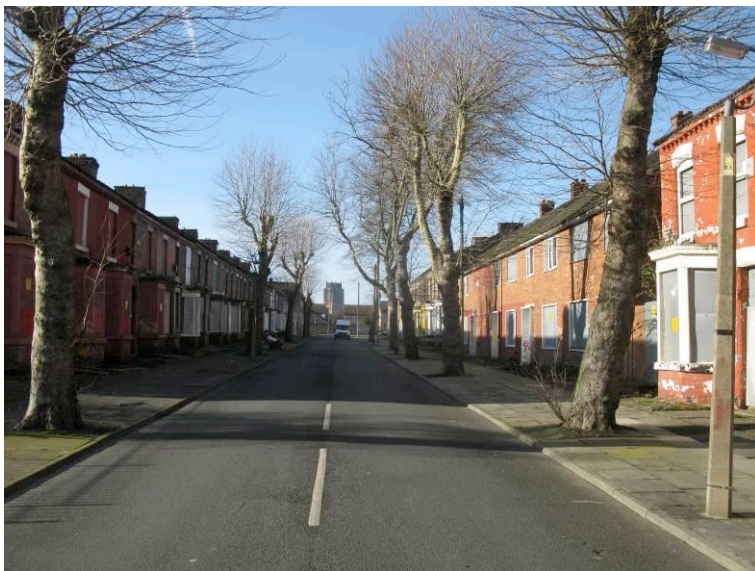
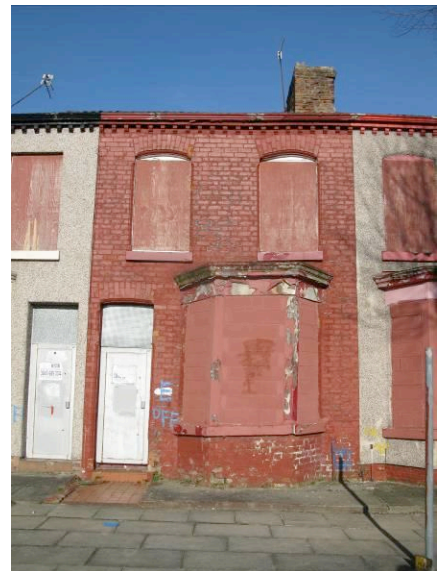
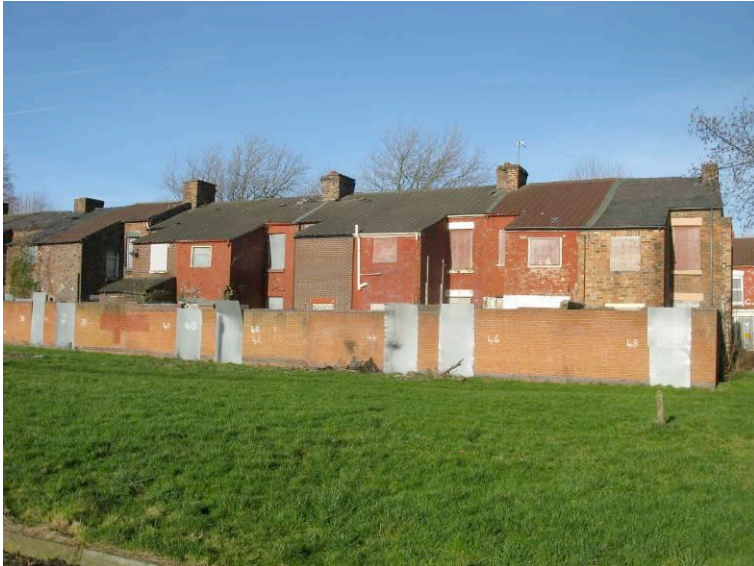
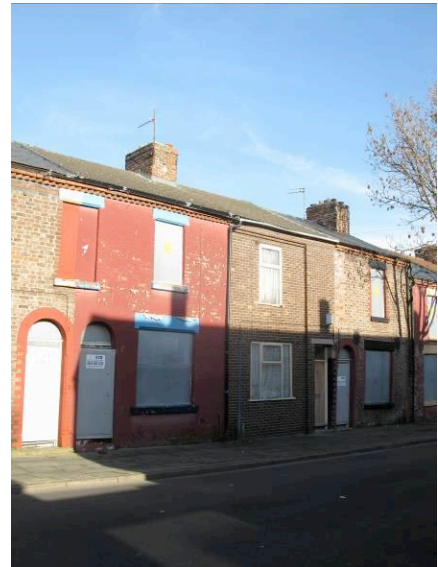
The buildings have clearly not been maintained for a considerable time, and certainly since they were boarded up. As ever in this situation their condition will deteriorate rapidly, particularly where water penetrates the structure and which will affect both timber roof and upper timber floors.

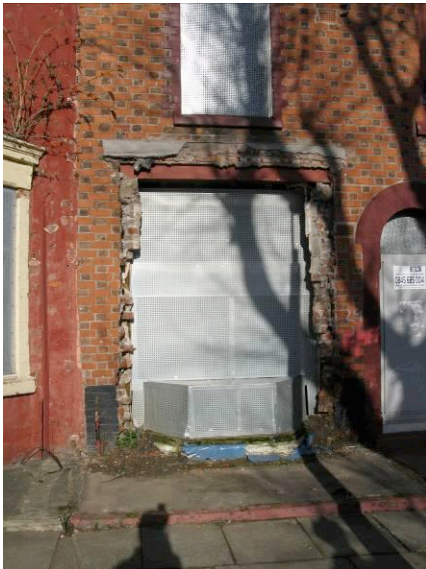
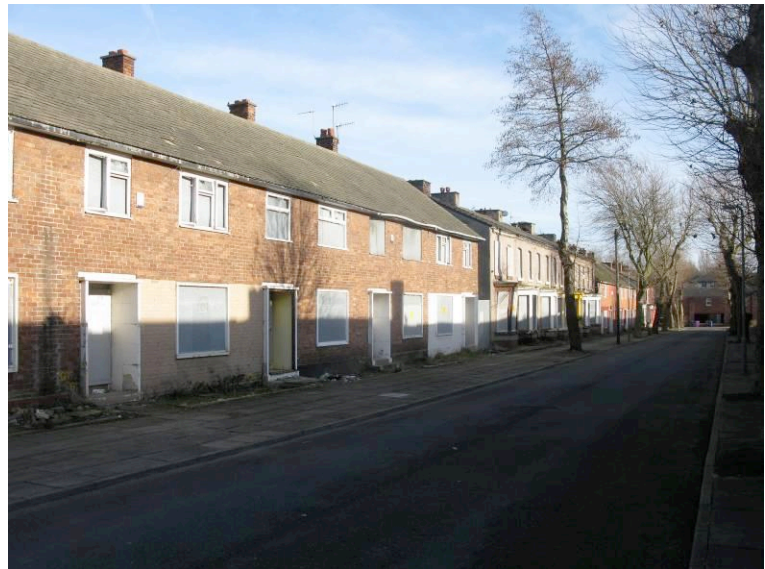
Elsewhere there are individual areas of greater damage, for instance where a bay window has been removed, and some lengths of original terraces, which have been replaced with more modern cavity construction. Some of the rear projecting accommodation have been re-built

Inevitably with such buildings in long terraces and over a relatively wide area, there are some areas of local movement. These tend to be through window openings, typically bays. Elsewhere there is some bowing of the front elevation concentrated a short way above ground level. However I would stress that related to the in excess of 400 buildings only a few of the buildings are affected significantly and to an extent that would warrant significant intervention or local re-building.

From my limited inspection of the buildings it is clear that it is perfectly practical to retain and re-use these buildings. Repairs will of course be required but I do not see these being difficult, there are likely to comprise re-roofing, with appropriate upgrading of insulation; chimney consolidation or local re-building of the heads; window and door repairs and replacement; repairs to decayed internal roof and floor structure, although this seems reasonably limited; local elevation repairs including re-pointing, some replacement of window heads etc.

In some buildings, a greater degree of work will be required including some re-building of elevations or part elevations such as bays, but again this is only a very small proportion of the overall number of buildings.
